**Grousemount Wind Farm
County Kerry**

Additional Information

**Report: Temporary Bridge at Ballyvourney, Flood Risk
Assessment**

**Report: Peat Stability Risk Assessment at Grousemount
Wind Farm**

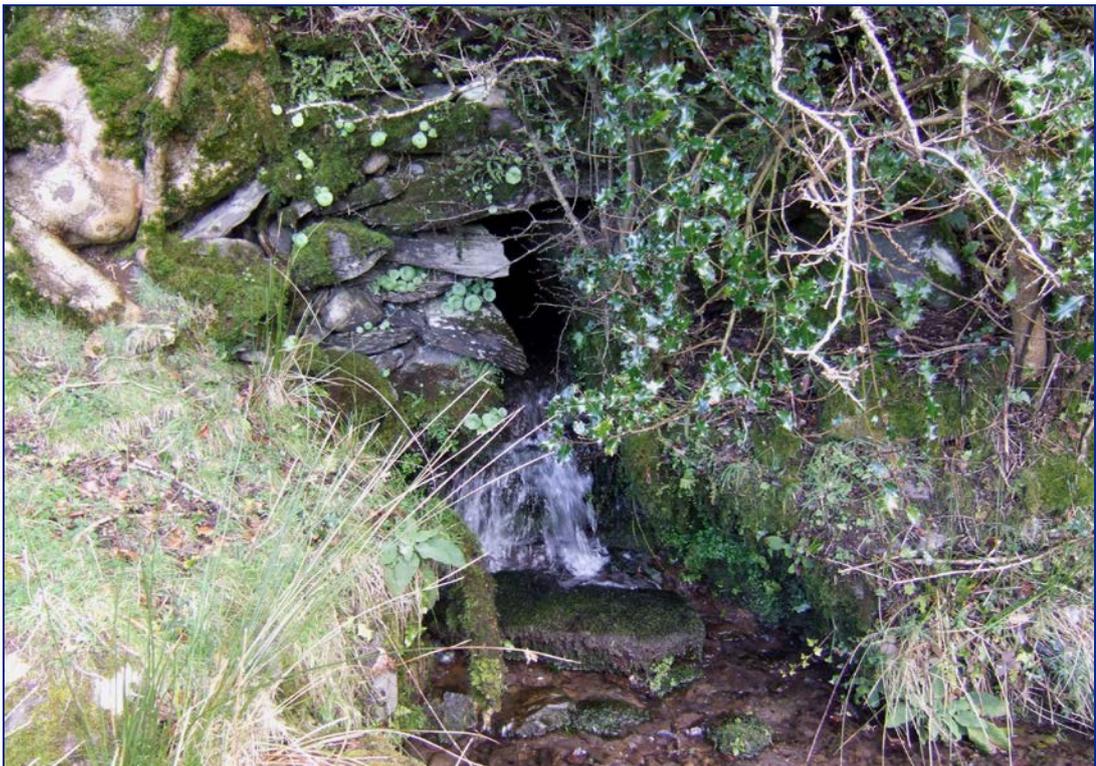
Figure 3.2: View of stone culvert in bank below N22. This will be covered by the proposed works.

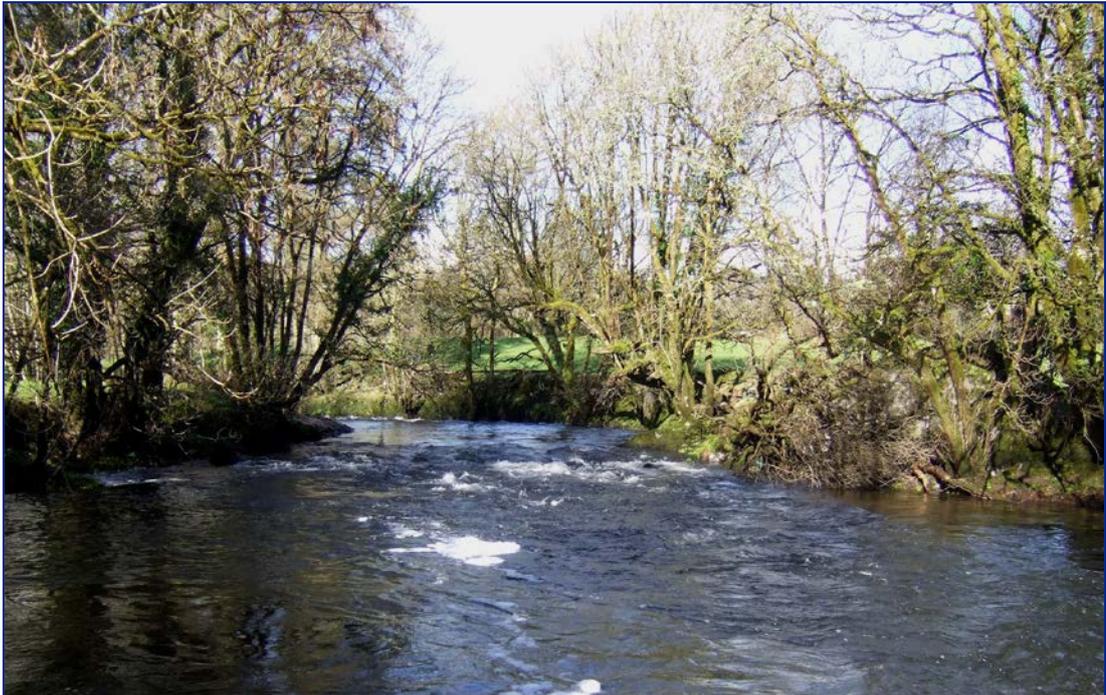
Figure 3.4: View looking west at bend in river where temporary bridge will be placed. A small number of trees will be removed from each of the banks.

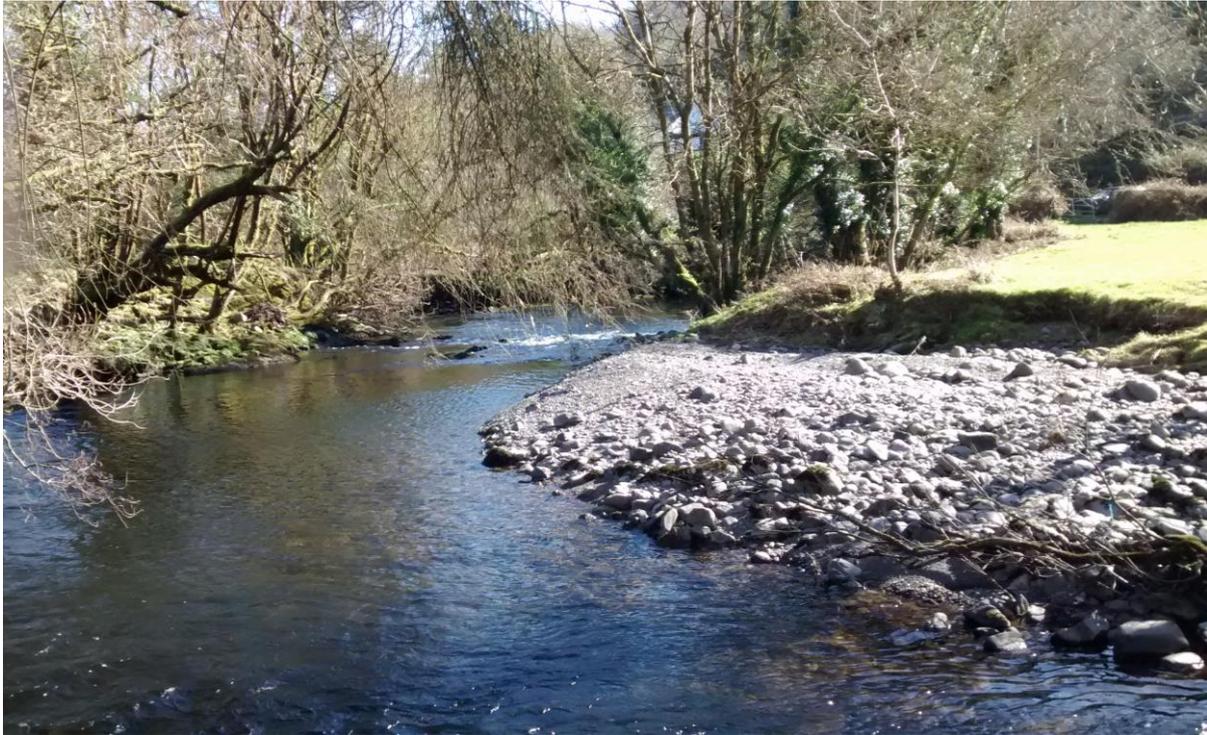
Figure 18 View of proposed bridge location looking east

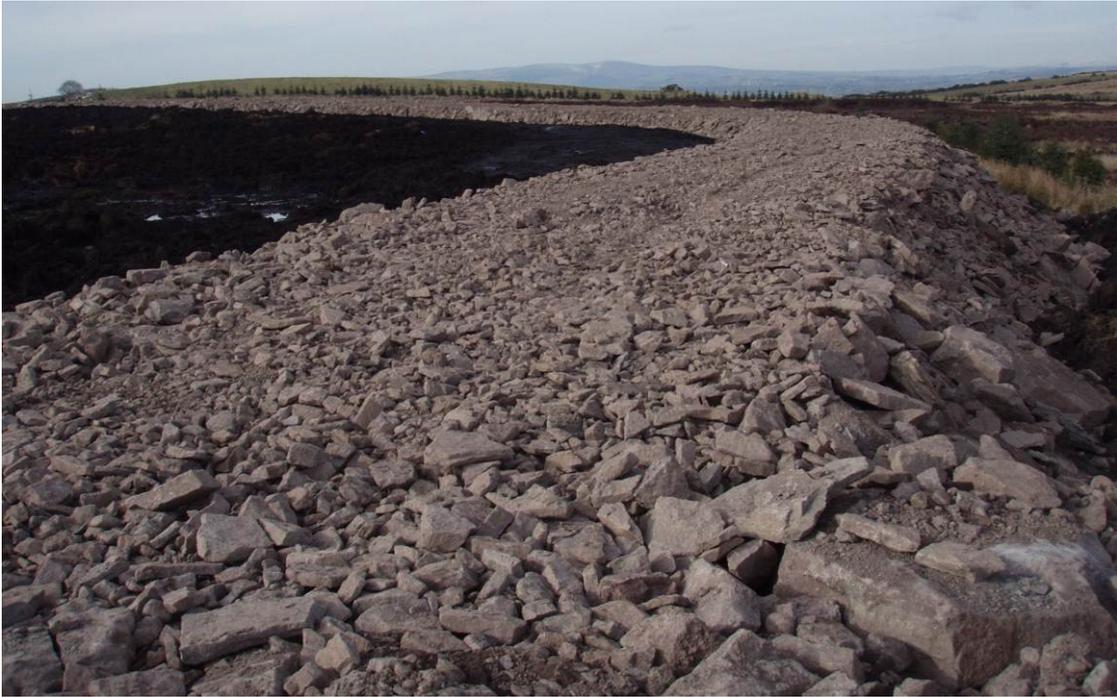
Figure 7-2 Rockfill peat repository on an existing ESB Wind Farm

Figure 7-2 shows an example of the successful storage of peat on an existing ESBI designed wind farm for ESB Wind Development.

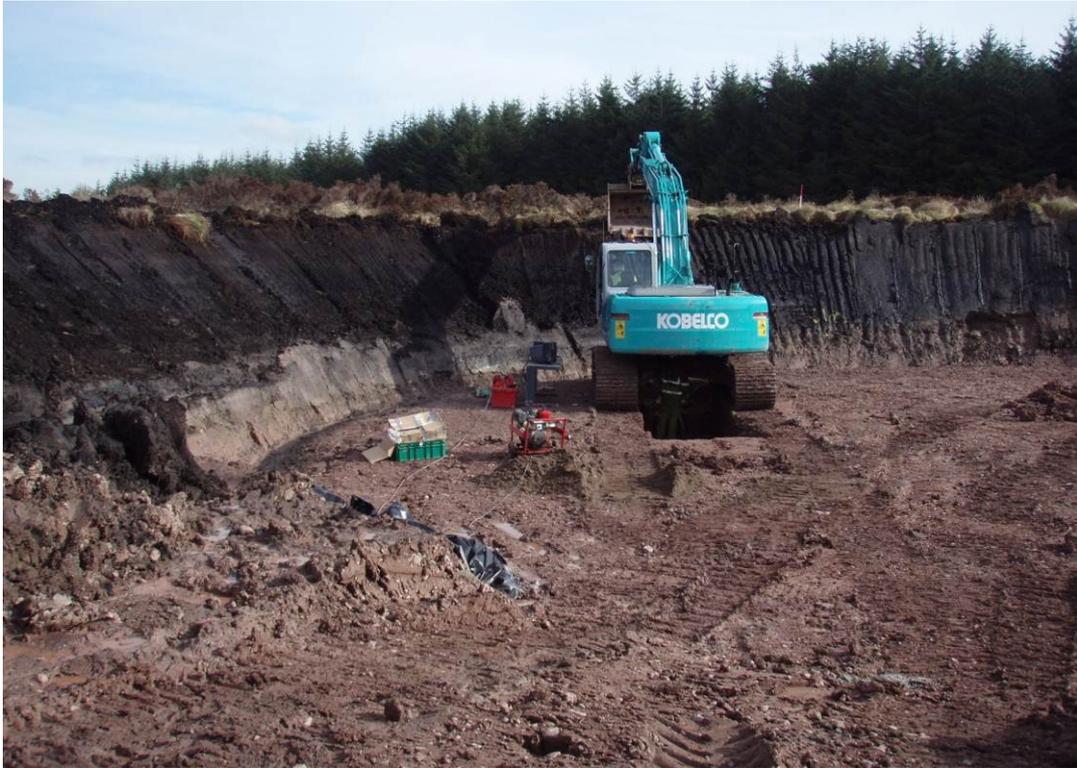
Figure 7-3 Turbine excavation trimmed back to a stable temporary side slope

Figure 7-3 shows an excavation in peat up to about 2.5 – 3.0 m deep on a previous ESB Wind Farm site in Co. Tyrone where the peat conditions were very favourable and the sides were trimmed back to temporary slopes of about 1V:1H during construction.

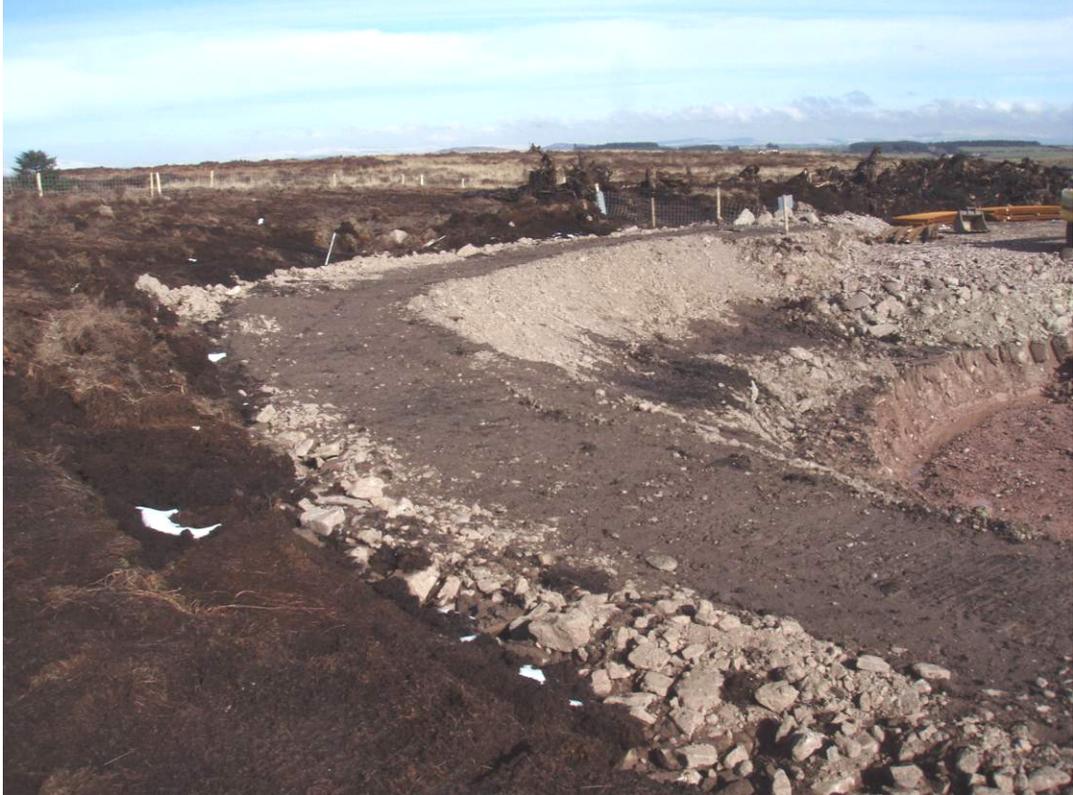
Figure 7-4 Rockfill berm around an area of deep peat on a previous ESB Wind Farm

Figure 7-4 shows a turbine excavation in 4.5 m of very soft and weak peat where a rockfill berm was constructed around the perimeter of the excavation to support the peat.
